Solving Comfort and Indoor Air Quality Issues: A Vintage Home in Miami, Florida

In this case study, we explore the experiences of a homeowner in Miami, Florida, who partnered with Comfort Dynamics, Inc., an HVAC design and contracting firm. Their mission was to address the unique challenges faced by the homeowner in their 1941 vintage residence, focusing on enhancing comfort and improving indoor air quality (IAQ).

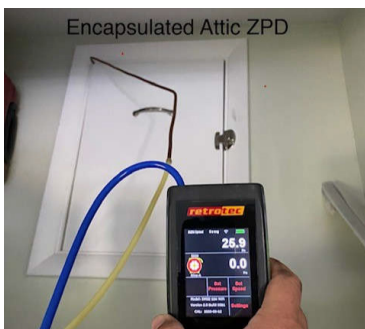
A tight encapsulated attic should have a reading of very close to zero, instead of the 25.9 value shown as measured.

- 1. Re-encapsulation of the Crawl Space:** By re-encapsulating the crawl space, the air leakage was reduced by 302 CFM50. This helps in improving energy efficiency and preventing moisture issues.

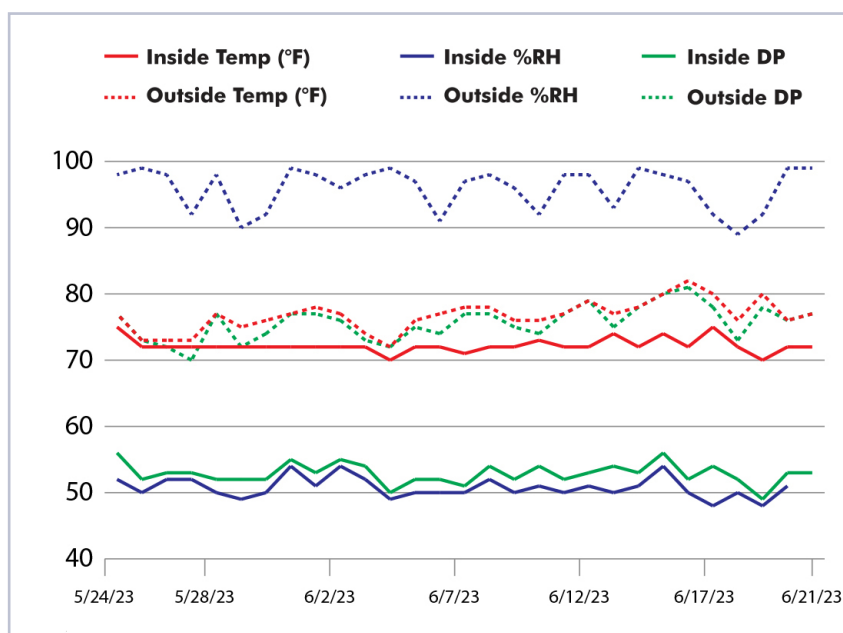
- 6. Haven Central Air Monitor & Controller:** The Haven Central Air Monitor & Controller was installed to monitor and control the Santa Fe Whole House Ventilating Dehumidifier, ensuring optimal performance, comfort, and indoor air quality. This device, along with the AWAIR IAQ monitors, provides real-time data on temperature, humidity, and IAQ, allowing the homeowner to track the improvements.
